## TÜV NORD TURKEY Industrial Services Inspection Report

INSPECTOR	Özgün Ozan TÜRK	TÜV ORDER NO.	21144227
PLACE & DATE	MASLAK	REPORT NO	RP-21144227-01
CUSTOMER	LINK YAPI SAN. VE TIC. A.Ş.	MANUFACTURER	LINK YAPI SAN. VE TIC. A.Ş.
CUSTOMER ORDER NO	-	MANUFACTURER ORDER NO	-
INSPECTION DATES	08.12.2016-09.12.2016	MANUFACTURER CONTACT	-
CUSTOMER CONTACTS	-	HARD STAMP	<input type="checkbox"/> Yes <input checked="" type="checkbox"/> No
REPORT TYPE	<input type="checkbox"/> Initial <input type="checkbox"/> Interm <input checked="" type="checkbox"/> Final		
ANNEXES	<input checked="" type="checkbox"/> Yes <input type="checkbox"/> No

This inspection includes 3rd party control of LINK YAPI SAN. VE TIC. A.Ş.'s site at Maslak / ISTANBUL.

It covers the tests made under the ANSI-ASHRAE 171-2008 standard according to the recommended load values of the SEISMIC and VIBRATING RESTRICTIVE equipment designed and manufactured by LINK YAPI. The audit findings are summarized below.

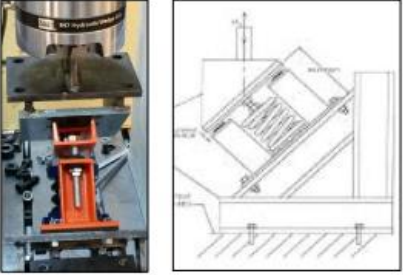
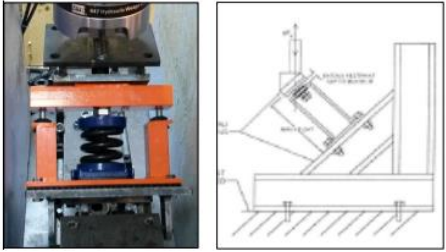
<p>Pic.9</p>	<p>Pic.10</p>

Name of the product	Test Positions	Recommended Load	Safety Coefficient	Target Load	Reached Load	Result	Picture
SLOTV2	Figure 4.1	(+/-) 12,00kN	1,50	-18,00kN	-19,441kN	OK	Pic.1
	Figure 4.2	(+/-) 12,00kN		18,00kN	19,361kN	OK	
	Figure 5	(+/-) 12,00kN		-18,00kN	-19,158kN	OK	Pic.2
	Figure 6	(+/-) 12,00kN		-18,00kN	-19,23kN	OK	Pic.3
	Figure 7	(+/-) 12,00kN		18,00kN	19,32kN	OK	Pic.4
	Figure 8	(+/-) 12,00kN		18,00kN	19,32kN	OK	Pic.5
SLOT2	Figure 4.1	(+/-) 16,00kN	1,50	-24,00kN	-26,04kN	OK	Pic.6
	Figure 4.2	(+/-) 16,00kN		24,00kN	25,82kN	OK	
	Figure 5	(+/-) 16,00kN		-24,00kN	-25,63kN	OK	Pic.7
	Figure 6	(+/-) 16,00kN		-24,00kN	-25,01kN	OK	Pic.8
	Figure 7	(+/-) 16,00kN		24,00kN	25,71kN	OK	Pic.9
	Figure 8	(+/-) 16,00kN		24,00kN	25,72kN	OK	Pic.10
SLOT2AC	Figure 4.1	(+/-) 24,00kN	1,50	-36,00kN	-38,84kN	OK	Pic.11
	Figure 4.2	(+/-) 24,00kN		36,00kN	38,34kN	OK	
	Figure 5	(+/-) 24,00kN		-36,00kN	-38,63kN	OK	Pic.12
	Figure 6	(+/-) 24,00kN		-36,00kN	-38,63kN	OK	Pic.13

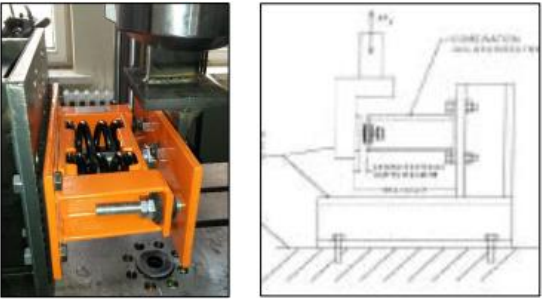
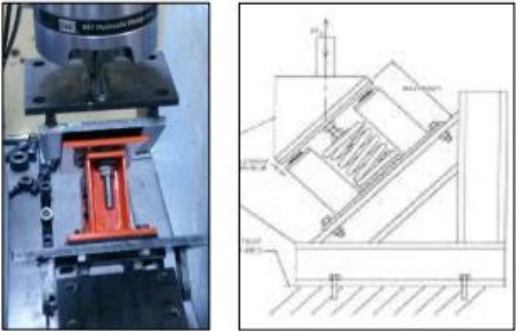
<p>Pic.13</p>	<p>Pic.14</p>

Figure 7	(+/-) 24,00kN		36,00kN	38,45kN	OK	Pic.14
	Figure 8	(+/-) 24,00kN		36,00kN	38,19kN	OK	Pic.15
SLOT4AP	Figure 4.1	(+/-) 48,00kN	1,50	-72,00kN	-77,15kN	OK	Pic.16
	Figure 4.2	(+/-) 48,00kN		72,00kN	74,04kN	OK	
	Figure 5	(+/-) 48,00kN		-72,00kN	-76,43kN	OK	Pic.17
	Figure 6	(+/-) 48,00kN		-72,00kN	-76,38kN	OK	Pic.18
	Figure 7	(+/-) 48,00kN		72,00kN	74,13kN	OK	Pic.19
	Figure 8	(+/-) 48,00kN		68,40kN	68,42kN	OK	Pic.20
SLZ	Figure 14A	(+/-) 26,00kN	1,50	-39,00kN	-41,96kN	OK	Pic.21
	Figure 14B	(+/-) 22,00kN		33,00kN	33,52kN	OK	Pic.22
	Figure 14C	(+/-) 23,00kN		35,50kN	35,45kN	OK	Pic.23
SLD1	Figure 19	(+/-) 26,00kN	1,50	-39,00kN	-42,00kN	OK	Pic.24
SLD2	Figure 16A.1	(+/-) 30,00kN	1,50	45,00kN	48,42kN	OK	Pic.25
	Figure 16A.2	(+/-) 30,00kN		-45,00kN	-48,37kN	OK	Pic.26
	Figure 16B	(+/-) 30,00kN		45,00kN	48,07kN	OK	Pic.27
	Figure 16C	(+/-) 30,00kN		45,00kN	48,19kN	OK	Pic.28
