TÜV NORD TURKEY Industrial Services Inspection Report

INSPECTOR	Özgün Ozan TÜRK	TÜV ORDER NO.	21144227
PLACE & DATE	MASLAK	REPORT NO	RP-21144227-02
CUSTOMER	LINK YAPI SAN. VE TIC. A.Ş.	MANUFACTURER	LINK YAPI SAN. VE TIC. A.Ş.
CUSTOMER ORDER NO	-	MANUFACTURER ORDER NO	-
INSPECTION DATES	08.12.2016-09.12.2016	MANUFACTURER CONTACT	-
CUSTOMER CONTACTS	-	HARD STAMP	<input type="checkbox"/> Yes <input checked="" type="checkbox"/> No
REPORT TYPE	<input type="checkbox"/> Initial <input type="checkbox"/> Interm <input checked="" type="checkbox"/> Final		
ANNEXES	<input checked="" type="checkbox"/> Yes <input type="checkbox"/> No

This inspection includes 3rd party control of LINK YAPI SAN. VE TIC. A.Ş.'s site at Maslak / ISTANBUL.

It covers the tests made under the ANSI-ASHRAE 171-2008 standard according to the recommended load values of the VIBRATING RESTRICTIVE equipment designed and manufactured by LINK YAPI. The audit findings are summarized below.

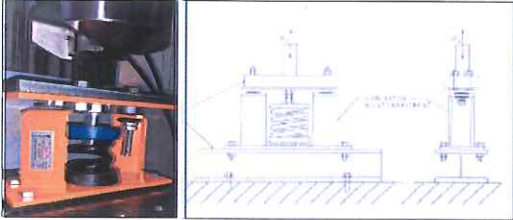
<p>Pic.1</p>	<p>Pic.2</p>

Name of the product	Test Positions	Recommended Load	Safety Coefficient	Target Load	Reached Load	Result	Picture
SLOTV2	Figure 4.1	(+/-) 12,00kN	1,50	-18,00kN	-19,441kN	OK	Pic.1
	Figure 4.2	(+/-) 12,00kN		18,00kN	19,361kN	OK	
	Figure 5	(+/-) 12,00kN		-18,00kN	-19,158kN	OK	Pic.2
	Figure 6	(+/-) 12,00kN		-18,00kN	-19,23kN	OK	Pic.3
	Figure 7	(+/-) 12,00kN		18,00kN	19,32kN	OK	Pic.4
	Figure 8	(+/-) 12,00kN		18,00kN	19,32kN	OK	Pic.5
SLOT2	Figure 4.1	(+/-) 16,00kN	1,50	-24,00kN	-26,04kN	OK	Pic.6
	Figure 4.2	(+/-) 16,00kN		24,00kN	25,82kN	OK	
	Figure 5	(+/-) 16,00kN		-24,00kN	-25,63kN	OK	Pic.7
	Figure 6	(+/-) 16,00kN		-24,00kN	-25,01kN	OK	Pic.8
	Figure 7	(+/-) 16,00kN		24,00kN	25,71kN	OK	Pic.9
	Figure 8	(+/-) 16,00kN		24,00kN	25,72kN	OK	Pic.10
SLOT2AC	Figure 4.1	(+/-) 24,00kN	1,50	-36,00kN	-38,84kN	OK	Pic.11
	Figure 4.2	(+/-) 24,00kN		36,00kN	38,34kN	OK	
	Figure 5	(+/-) 24,00kN		-36,00kN	-38,63kN	OK	Pic.12
	Figure 6	(+/-) 24,00kN		-36,00kN	-38,63kN	OK	Pic.13

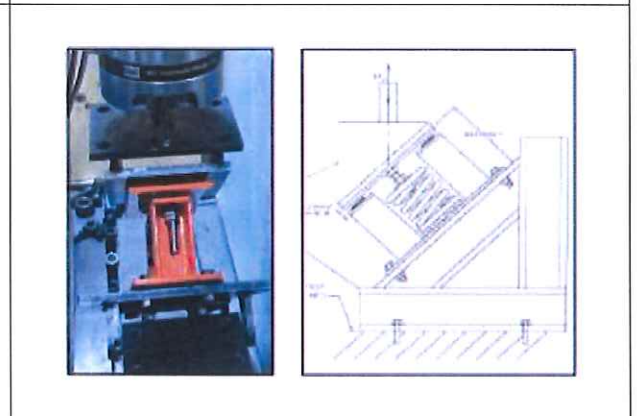
Figure 7	(+/-) 24,00kN		36,00kN	38,45kN	OK	Pic.14
	Figure 8	(+/-) 24,00kN		36,00kN	38,19kN	OK	Pic.15
SLOT4AP	Figure 4.1	(+/-) 48,00kN	1,50	-72,00kN	-77,15kN	OK	Pic.16
	Figure 4.2	(+/-) 48,00kN		72,00kN	74,04kN	OK	
	Figure 5	(+/-) 48,00kN		-72,00kN	-76,43kN	OK	Pic.17
	Figure 6	(+/-) 48,00kN		-72,00kN	-76,38kN	OK	Pic.18
	Figure 7	(+/-) 48,00kN		72,00kN	74,13kN	OK	Pic.19
	Figure 8	(+/-) 48,00kN		68,40kN	68,42kN	OK	Pic.20
