23-IS-2033

INSPECTION REPORT

23-IS-2033-TAT-23-0547

This report was prepared on behalf of LINK YAPI SAN. VE TİC. A.Ş. on 02.11.2023 in order to determine the performance of the ELASTOMER VIBRATION RECEIVER product under load.

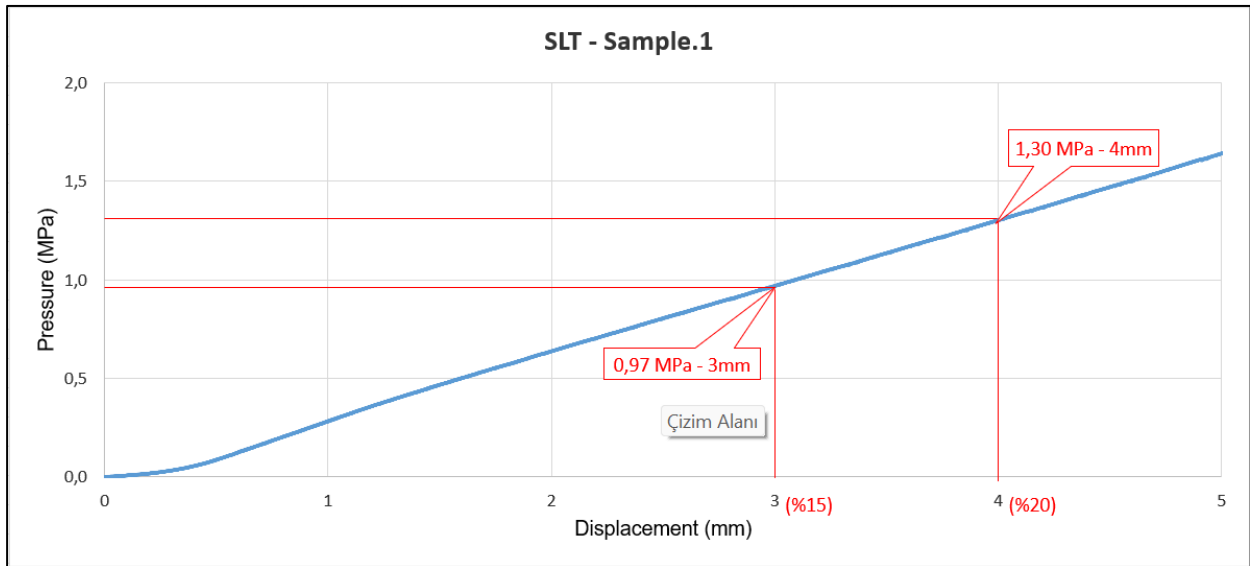
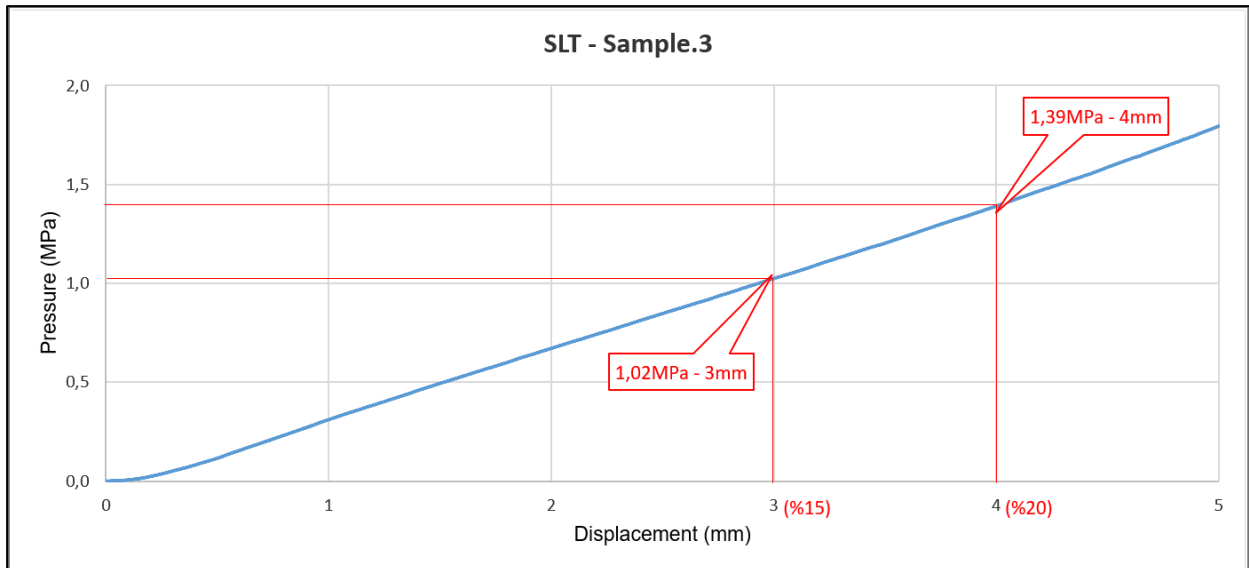
Below are the graphs containing the individual test results of the 4 samples, as well as the Average Strength Graph created using the results of the 4 samples.

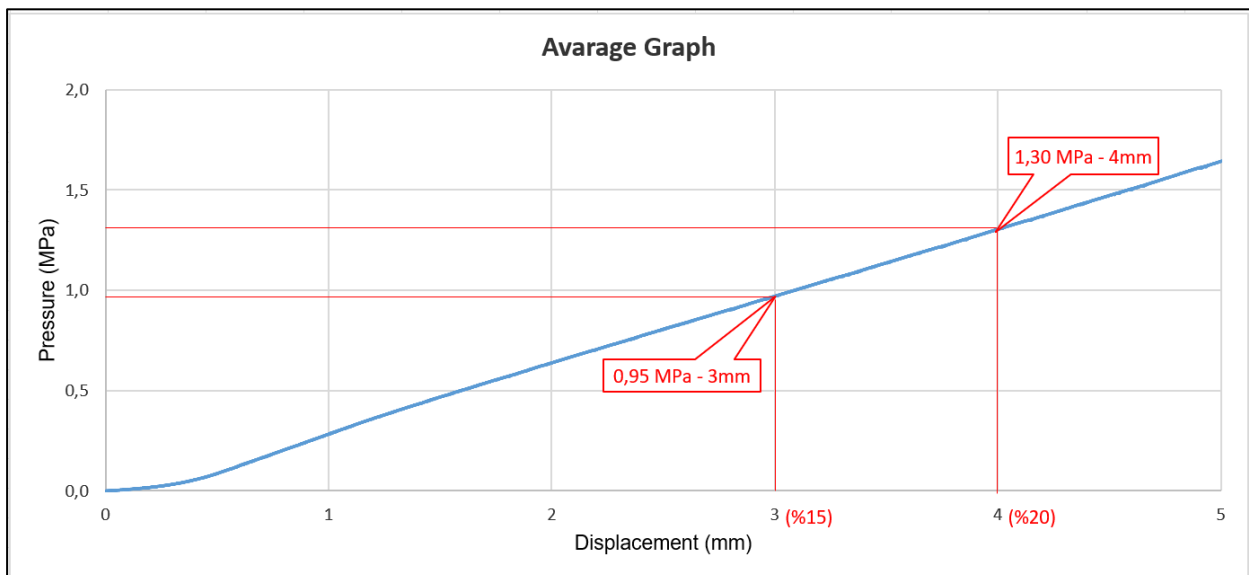
Average Strength Graph

The values in the Average Strength Chart are the values recommended by the Customer.
